NASA Technical Memorandum

NASA TM - 82552

IN-HOUSE WELDING STUDIES SUPPORTING THE PRELAUNCH ASSESSMENT OF THE STS-6 MAIN ENGINES

By Lisa L. Hawkins

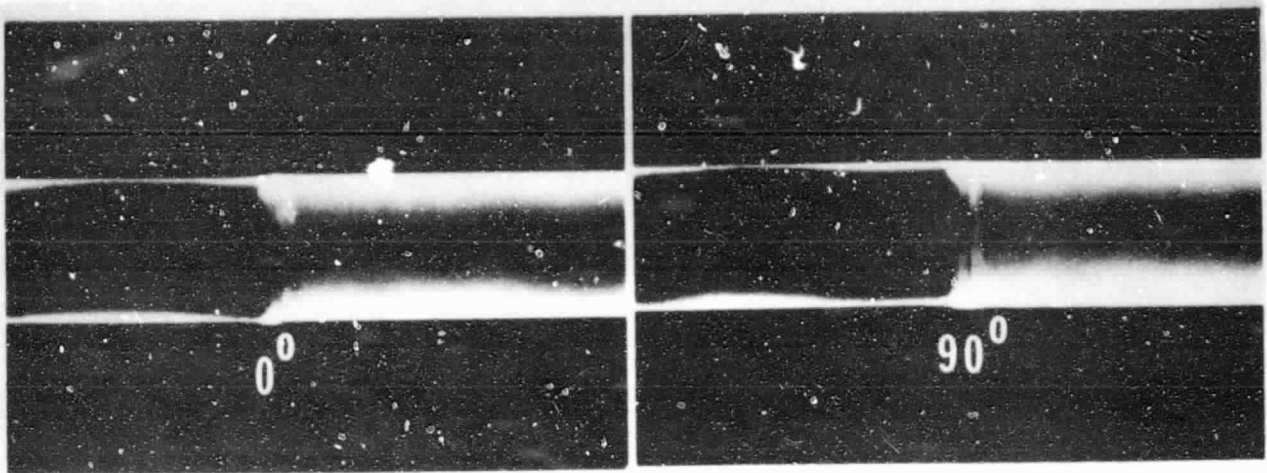
SPECIMEN #3

The following observations were made: If the inert gas shield is removed from the tack weld before it cools, the tacks will interfere with metal flow, creating a flaw as noted in Figure 7, Specimen No. 3. Also, if any cracks occur in the tacks, they will remain in the final weld.

Figure 13 lists X-ray defects and mechanical test results for each specimen. From Figures 12 and 13, it can be seen that radiography is an accurate indicator of most serious weld defects (such as the large lack of penetration seen in Specimen No. 3, Figure 7), but that less evident defects, such as restricted metal flow (see Specimen No. 6, Figure 7), are difficult to determine by radiography. In this limited data sample, there appears to be no good correlation between radiographic results and mechanical test data. Consistent with our experience on other programs, X-ray inspection alone is not adequate to determine overall weld quality.

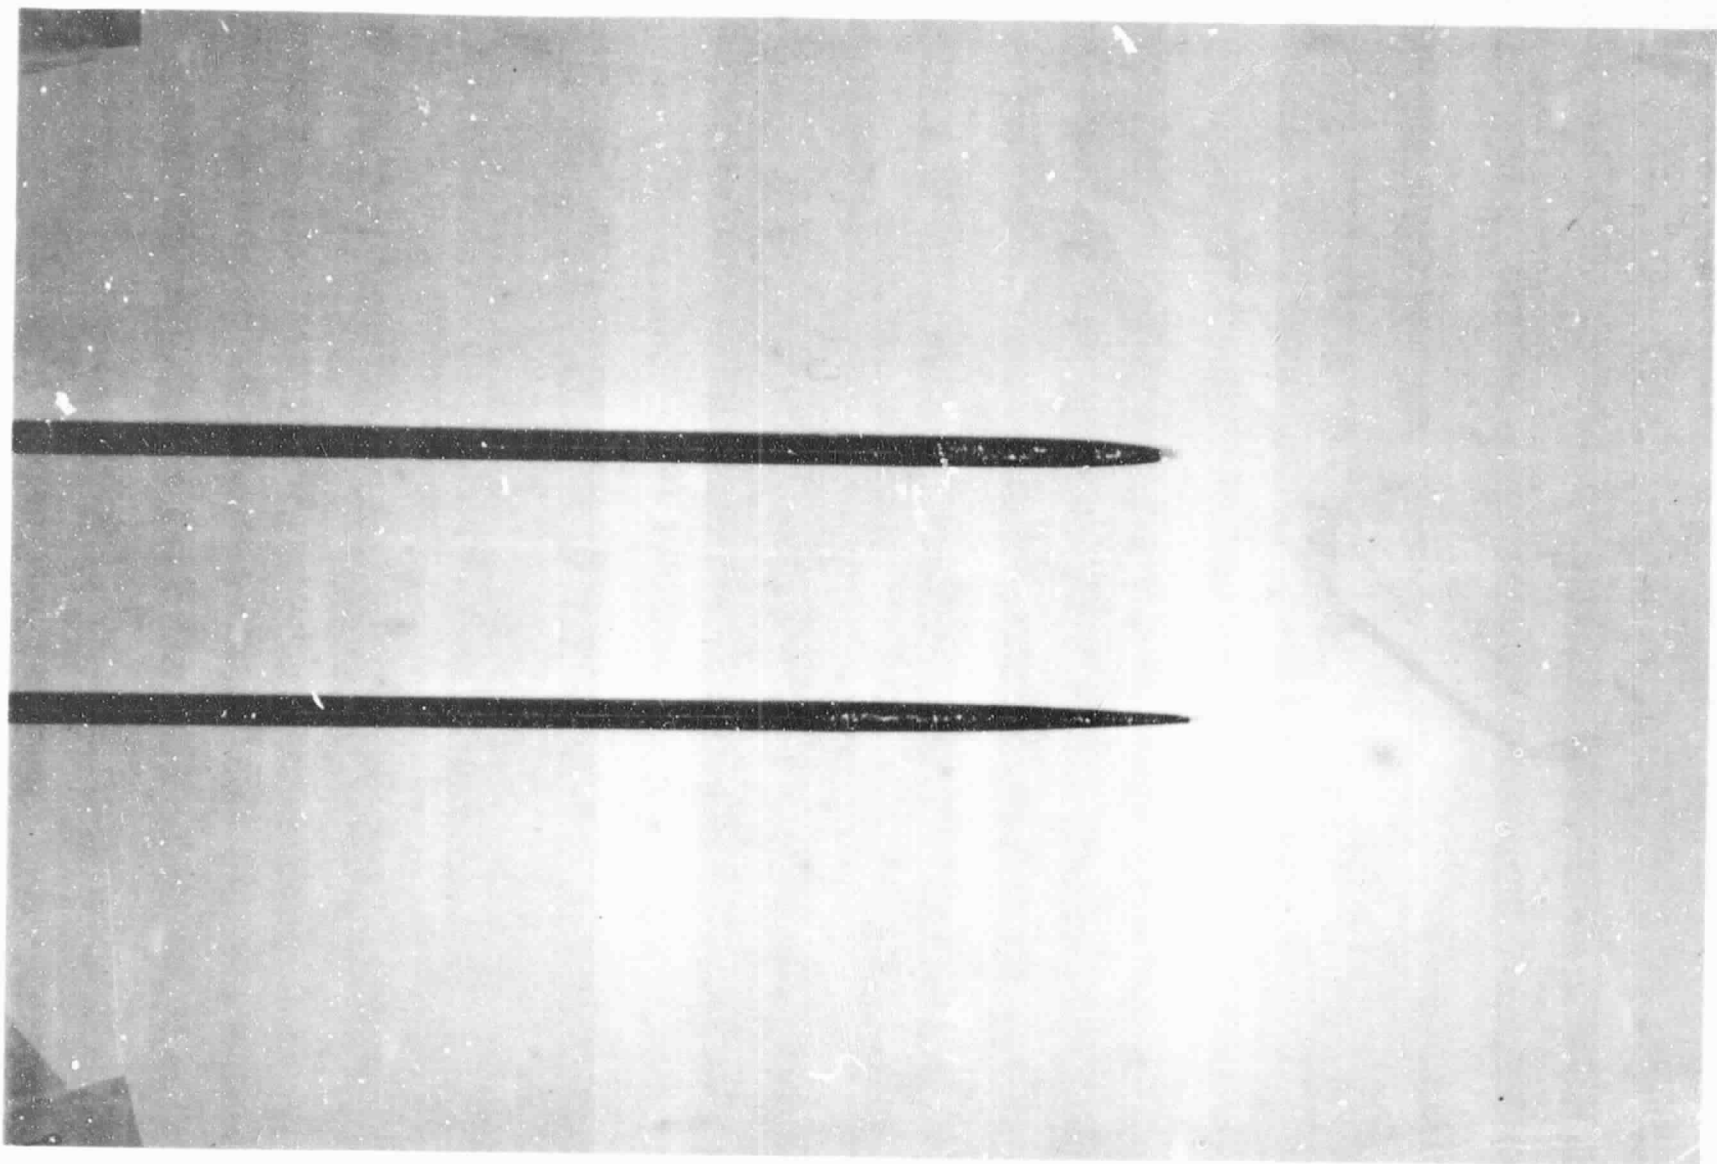
Figure 8. Electrode configuration.

The configuration of the electrode proved to be critical. A 0.040 in. diameter thoriated tungsten electrode was tapered for a length of 5/16 to 3/8 in. Our observations showed that, when the tip of the electrode was left sharp, a ball of hot molten metal formed on the tip of the electrode, causing the arc to wander along the surface of the ball. When the tip of the electrode was somewhat blunted, this problem was solved. Figure 8 shows the tapered electrode before and after blunting.

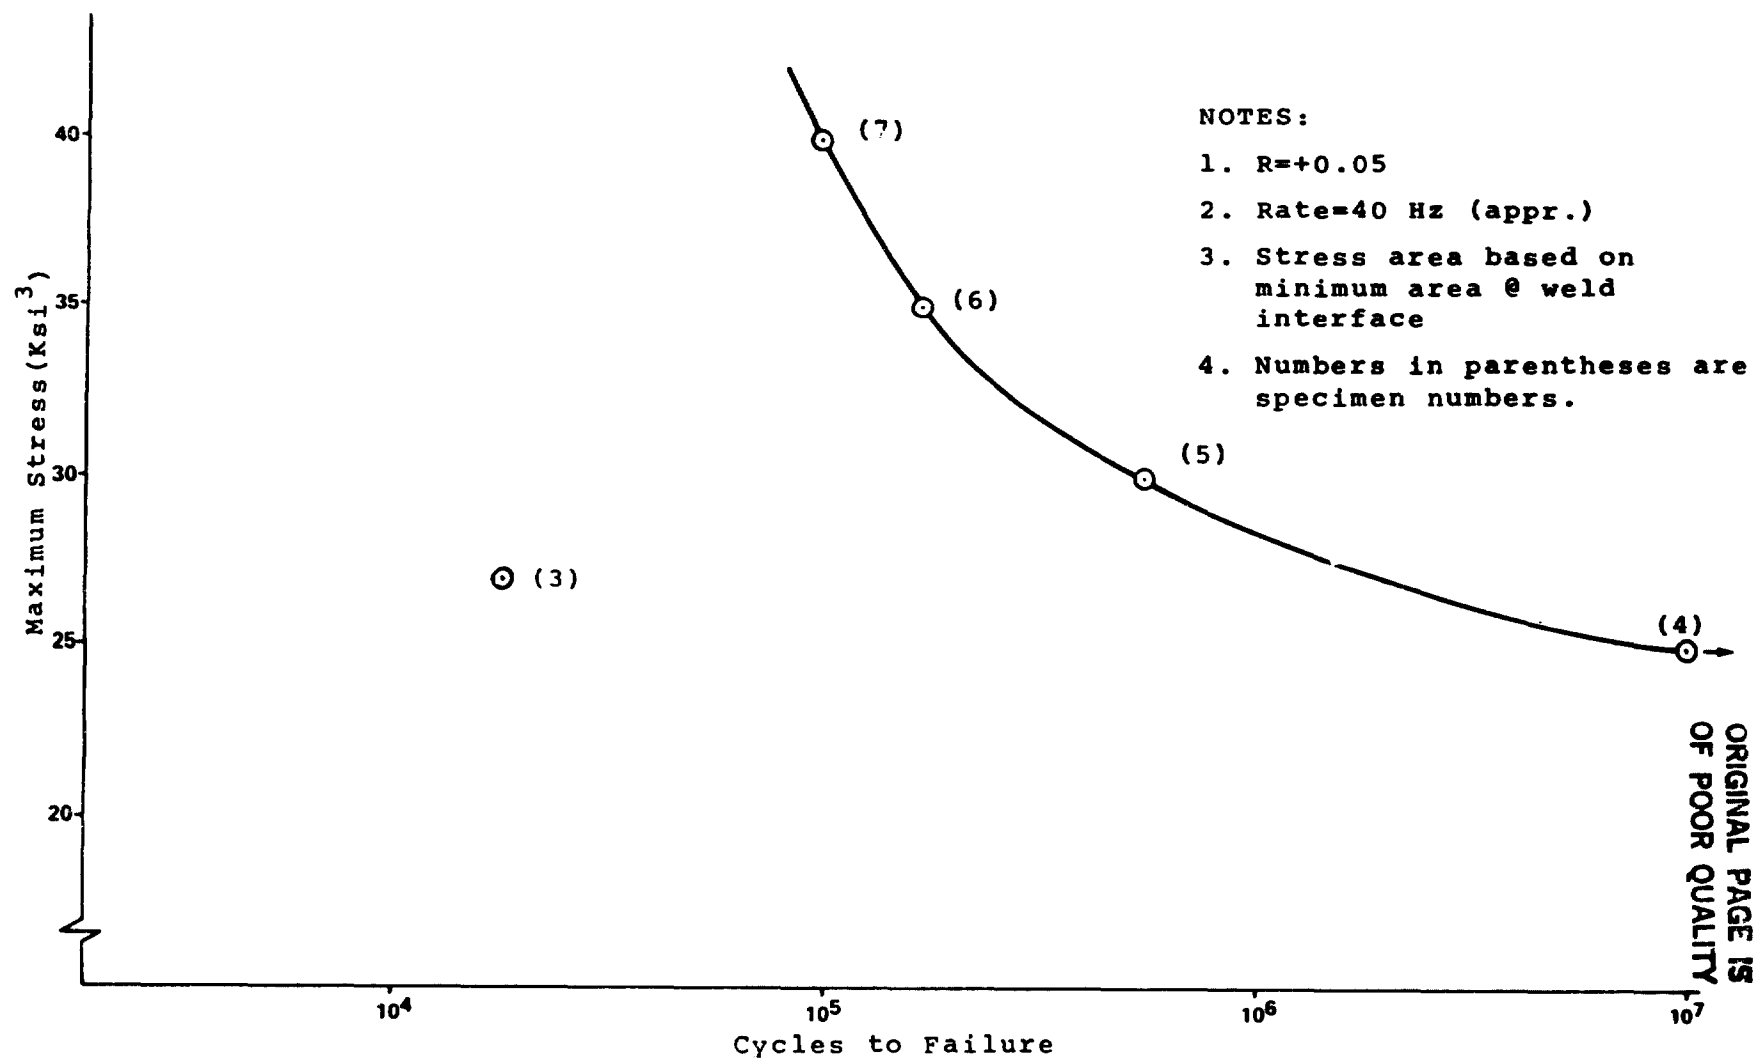
Figure 12. S-N data: HEX specimens.

the procedures outlined in this report. The remaining five specimens were evaluated in high-cycle fatigue, with a stress ratio of 0.05 (Stress ratio = Minimum stress / Maximum stress). Most of the specimens failed at the edge of the weld in the Haynes 188 material. Data for these tests are plotted in Figure 12.

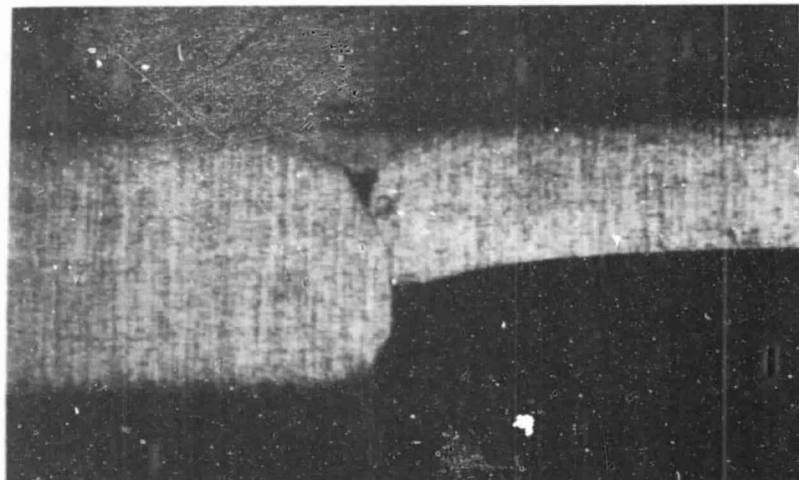
SPECIMEN #2a

"Bridging" was easily achieved by feeding in excess filler wire to cool the arc and limit penetration. Visual and surface inspection of the bridged specimens indicated the welds were acceptable, but sections revealed lack of penetration in several cases (Figure 16, Specimens 2a and 3). There was also a lack of penetration noted during sectioning of specimens where weld shrinkage pulled the unfused region of the joint into a very tight crack. Radiography had failed to reveal this problem (Figure 16, Specimens 1a and 2b). An incidental finding was that there appears to be a high potential for residual stress in these joints, as evidenced by the "buckling" of the thinner material in the specimens shown in Figure 16.

Simulation of the weld 56 joint on the HPFTP revealed a number of constraints on the welder as well as a procedure that is difficult to follow, resulting in inconsistent welds. In addition, NDE procedures used to date have not been sufficient to detect unfused regions of the joint. In view of these findings, it is recommended that this joint be reviewed by design and manufacturing.
